**REFINEMENT OF PROMISING COATING COMPOSITIONS  
FOR DIRECTIONALLY CAST EUTECTICS**

**FINAL REPORT**

UNITED TECHNOLOGIES CORPORATION  
Pratt & Whitney Aircraft Group  
Commercial Products Division

NATIONAL AERONAUTICS AND SPACE ADMINISTRATION  
NASA-Lewis Research Center  
Contract NAS3-18920

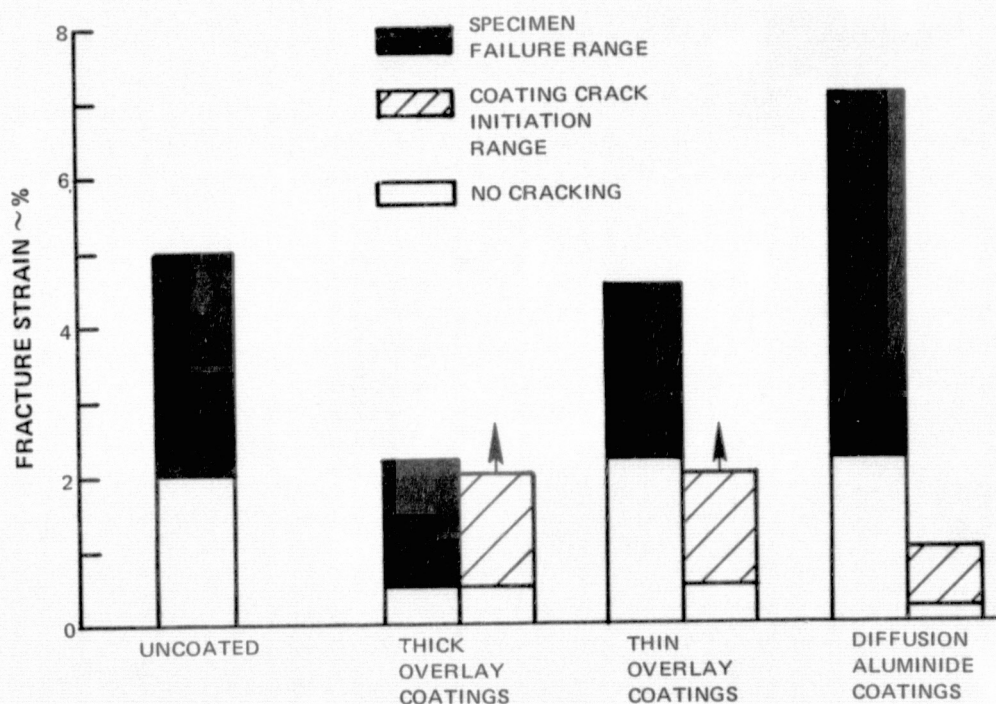
Figure 2 578 K Ductility Tests of Coated  $\gamma/\gamma'$ - $\delta$  (6Cr) show the Influence of the Coating on Fracture Strain of the Substrate.

Analysis of ductility tests conducted at 578 K indicated that the mechanical properties of the coating could affect the fracture strain of the eutectic alloy substrate as indicated in Figure 2. In order to put these results into perspective, it should be noted that the purpose of this tensile ductility test is to verify that the fracture strains of the coatings exceed values (0.15 to 0.35 percent strain) which are expected in a typical gas turbine airfoil. These results indicate that the fracture strains of all the coating systems which have been evaluated on the  $\gamma/\gamma'$ - $\delta$  alloys exceed the magnitude of anticipated thermal strains with the possible exception of the NiCrAlY + Al system.

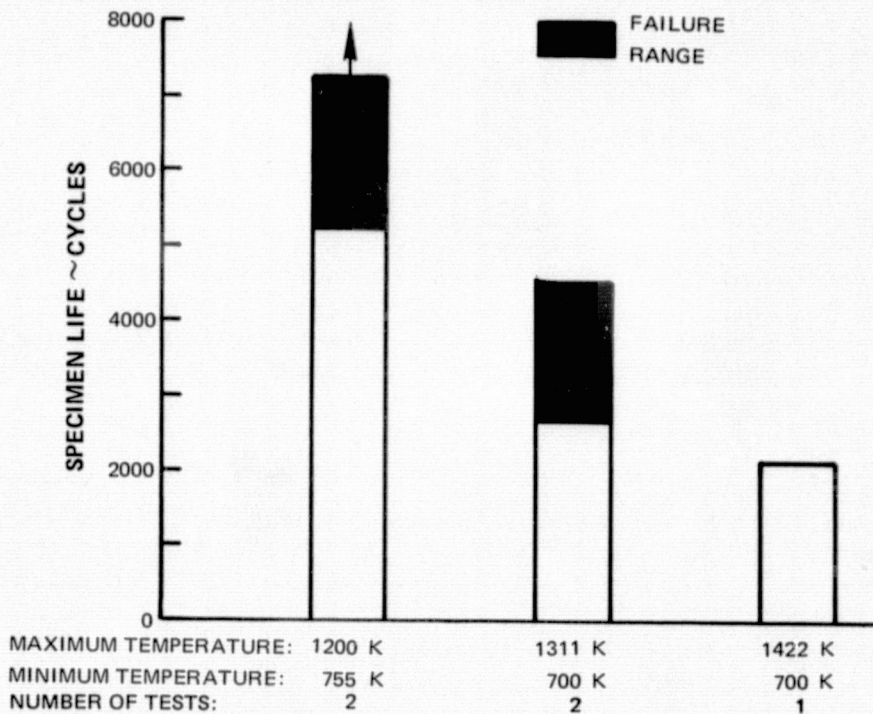
Figure 3 Cycle I (0.3% Strain Range) Thermomechanical Fatigue Life of NiCrAlY and NiCrAlY + Pt Coated  $\gamma/\gamma' - \delta$  (6Cr) Alloy.

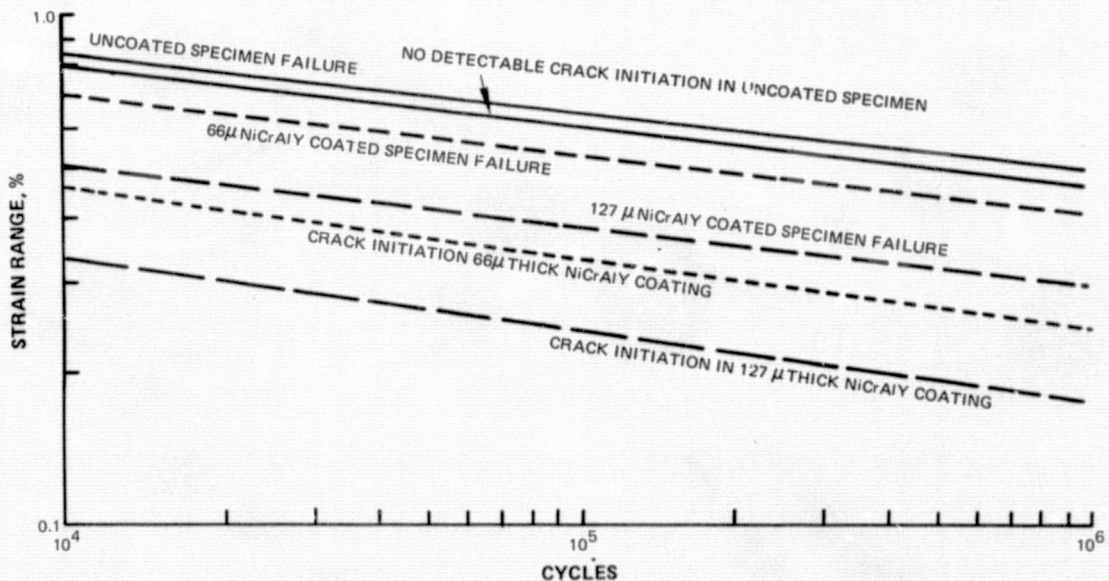
Figure 4 Effect of NiCrAlY Coating Thickness on 977 K Isothermal Fatigue of  $\gamma/\gamma' - \delta$  (6Cr) Alloy.

Isothermal fatigue and furnace hot corrosion tests indicated that 63 $\mu$  NiCrAlY, NiCrAlY + Pt and platinum modified diffusion aluminide (Pt + Al) coating systems are capable of protecting the relatively cooler surfaces of the blade root. Test data and a fracture mechanics analysis showed that coating thickness has a significant effect on both coating crack initiation and specimen failure. Fatigue data for 66 and 127 $\mu$  NiCrAlY coated  $\gamma/\gamma'$ - $\delta$  specimens illustrates this behavior in Figure 4.

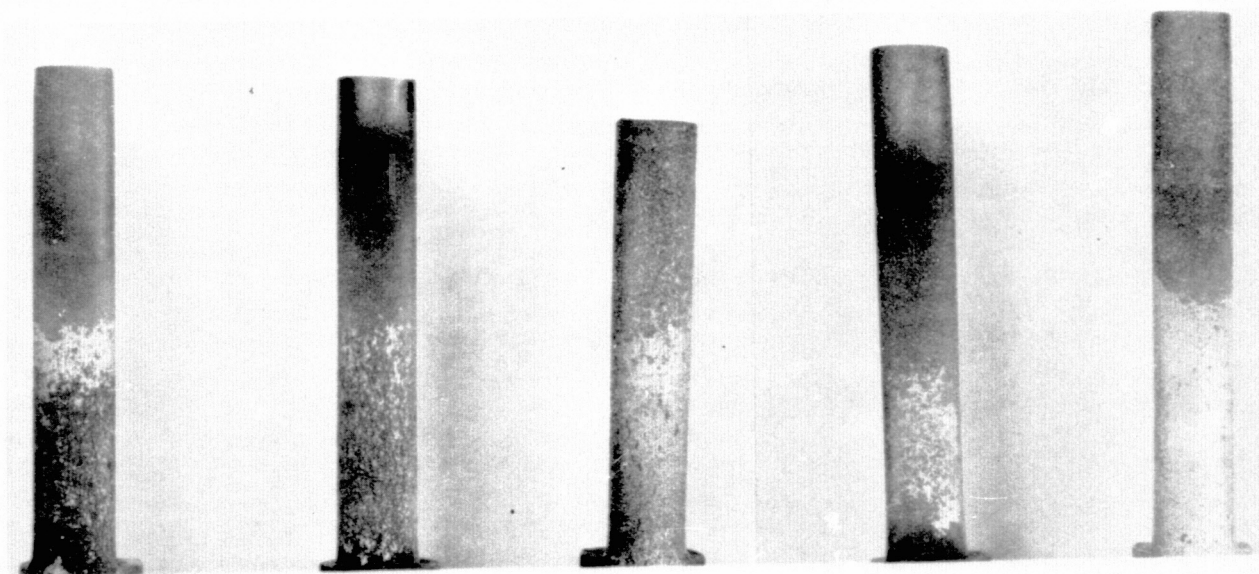
Figure 5

NiCoCrAlY	NiCoCrAlY + Pt	NiCrAlY + Al	NiCrAlY + Pt	NiCrAlY
VISUAL DETECTION OF THERMAL FATIGUE CRACKING:	136 HOURS	56 HOURS	297 HOURS	NOT DETECTED	NOT DETECTED
INITIAL DETECTION OF OXIDE SCALE SPALLATION:	126 HOURS	126 HOURS	56 HOURS	194 HOURS	126 HOURS

Visual Appearance of Coated  $\gamma/\gamma'$  -  $\delta$  Specimens After 505 Hours of Evaluation in 1366 K (2000°F) Burner Rig Cyclic Oxidation Test (Cycle: 27 Minutes Hot - 3 Minutes Forced Air Cool). (K-15096)

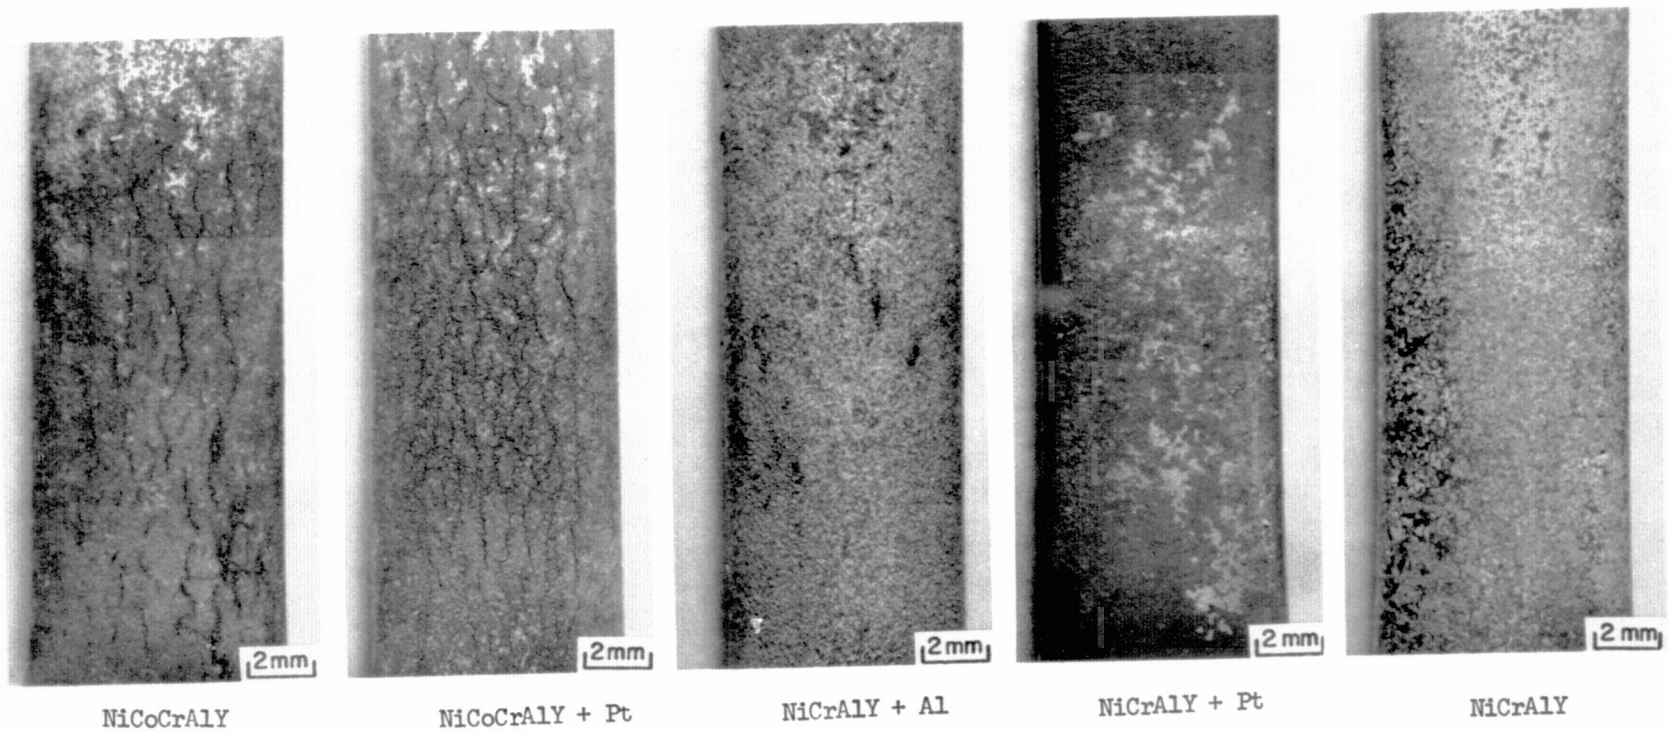
Figure 6 Visual Appearance of Coatings in Hot Zone Region of  $\gamma/\gamma'$  -  $\delta$  Specimens After 505 Hours of Evaluation in 1366 K (2000°F) Burner Rig Cyclic Oxidation Test (Cycle: 27 Minutes Hot - 3 Minutes Forced Air Cool). (K-15098)

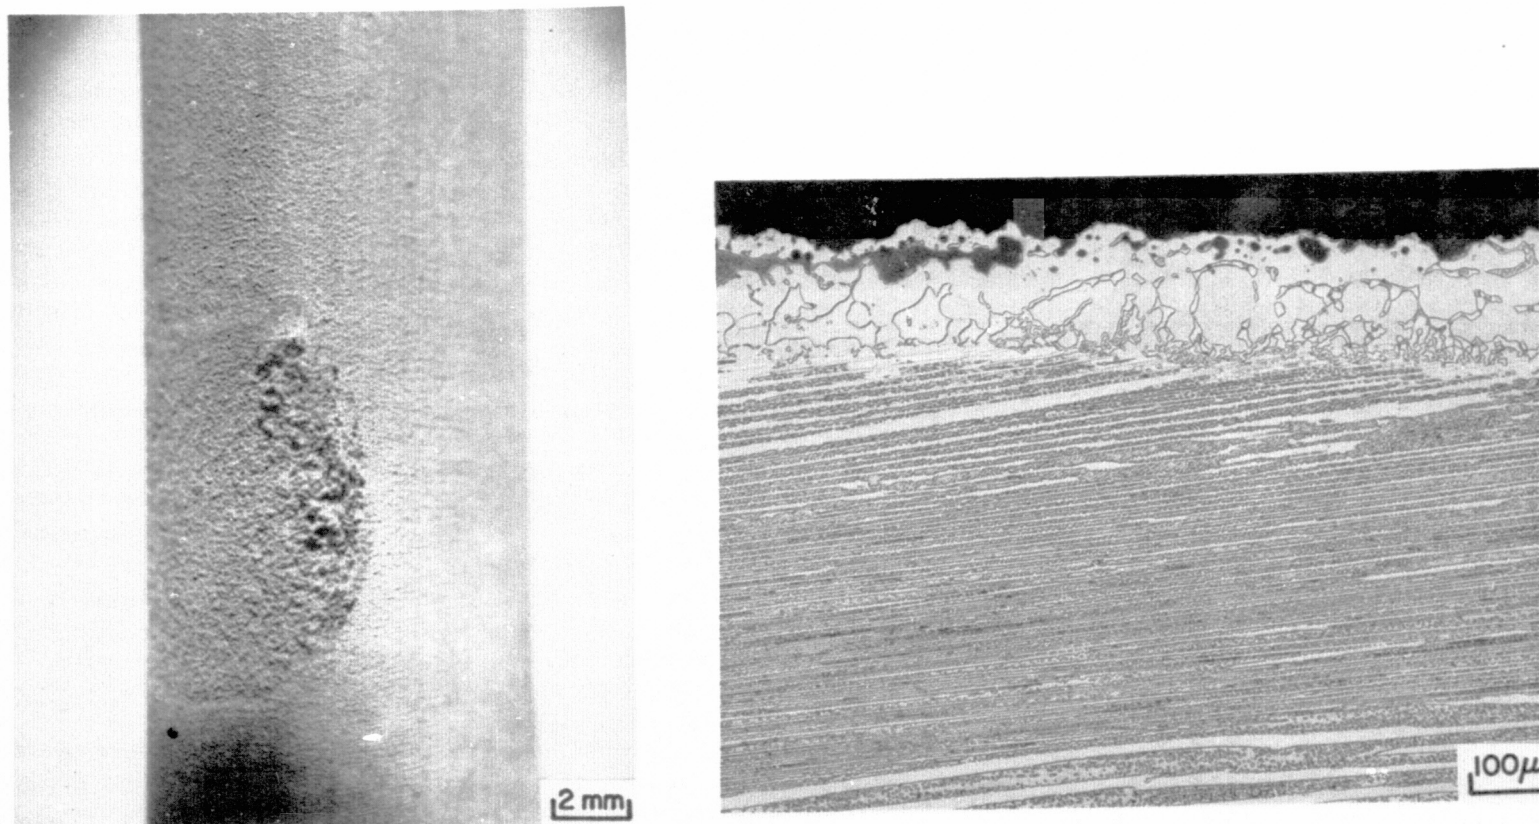
*Figure 7 Incipient Melting Condition Which Resulted in the Failure of the Pt + Al Coated  $\gamma/\gamma'$ - $\delta$  Specimen After 172 Hours of Evaluation in 1366 K (2000°F) Burner Rig Cyclic Oxidation Test (Cycle: 27 Minutes Hot – 3 Minutes Forced Air Cool) (K-13335)*

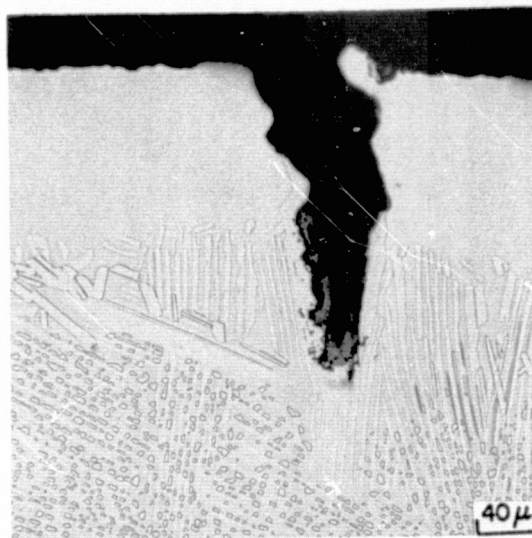
**Figure 11** Pretest and Post-Test Microstructures of NiCrAlY + Pt Coated  $\gamma/\gamma'$ - $\delta$  Specimen After 505 Hours of Evaluation in 1366 K (2000°F) Burner Rig Cyclic Oxidation Test (Cycle: 27 Minutes Hot – 3 Minutes Forced Air Cool).

Pretest and post-test microstructures of both the NiCrAlY + Pt and NiCrAlY coated specimens are provided in Figure 11 and 12, respectively. These figures indicate that the post-test coating microstructures were similar after the 505 hours exposure in the 1366 K burner rig. In both cases, the coating was  $\gamma$  phase at the end of testing. A continuous approximately 40 to  $50\mu$  thick band of  $\gamma'$ (Ni<sub>3</sub>Al) phase was present in the diffusion affected substrate zone of the NiCrAlY + Pt coated specimen. The total thickness of the diffusion affected substrate zone was approximately 60 to  $70\mu$ ; the balance of the interdiffusion zone thickness consisted of a thin  $\gamma + \gamma'$  layer adjacent to the unaffected  $\gamma/\gamma' - \delta$  substrate. The interdiffusion zone of the NiCrAlY coated specimen was similar with the exception that the  $\gamma'$  band was thinner and, in some areas, semi-continuous in the hot zone as a result of aluminum loss by oxidation; the  $\gamma'$  band was continuous in a slightly cooler region of the erosion bar.

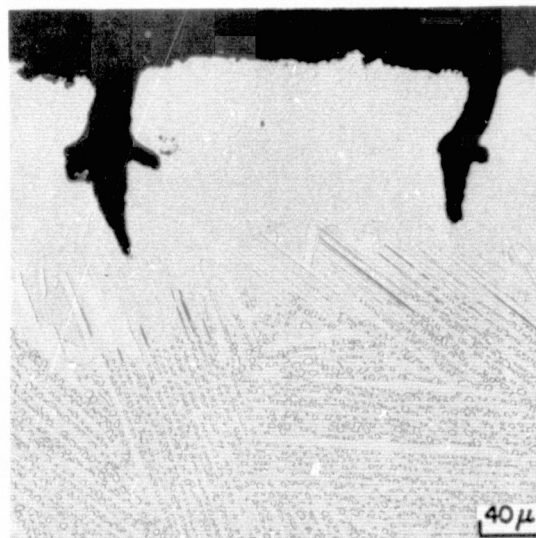
**Figure 12** Pretest and Post-Test Microstructures of NiCrAlY Coated  $\gamma/\gamma'$ - $\delta$  Specimen After 505 Hours of Evaluation in 1366 K (2000°F) Burner Rig Cyclic Oxidation Test (Cycle: 27 Minutes Hot – 3 Minutes Forced Air Cool).

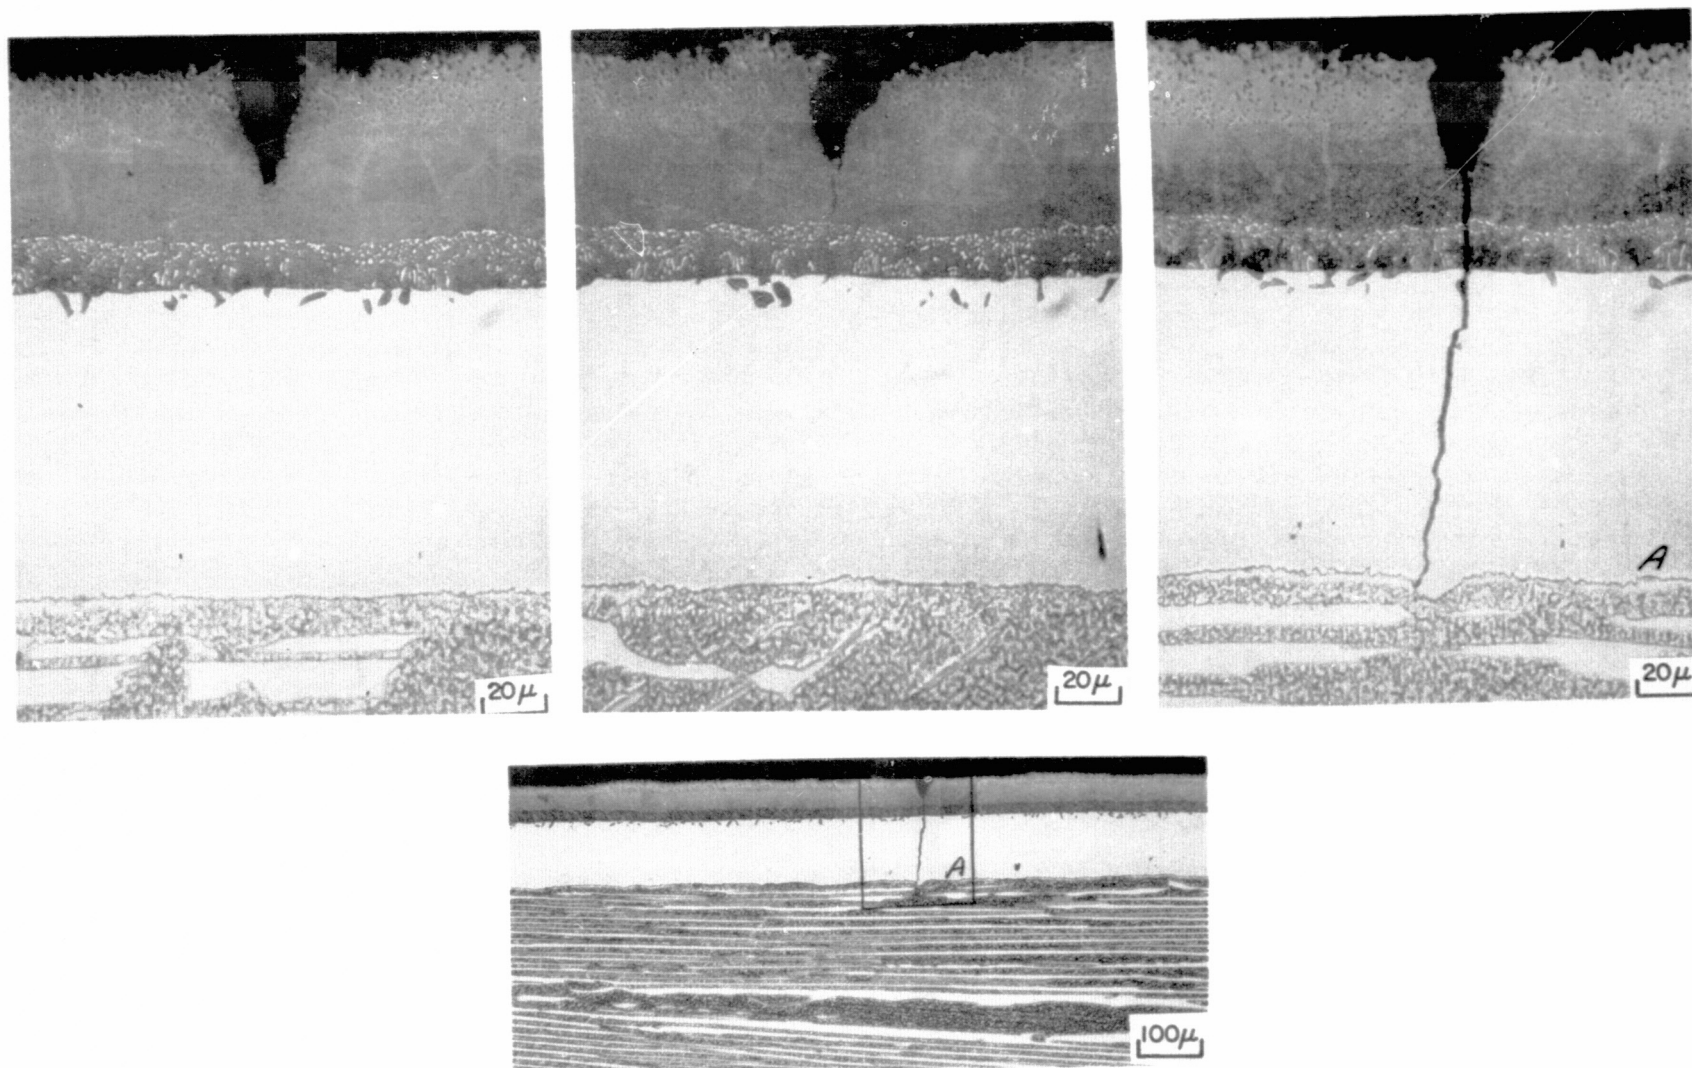
Figure 13 Microstructure of Coating Cracks in Virgin Low Aluminum NiCrAlY + Diffusion Aluminide (Pack, Inward) Coated  $\gamma/\gamma'$  -  $\delta$  Burner Rig Specimen. (K-13337)

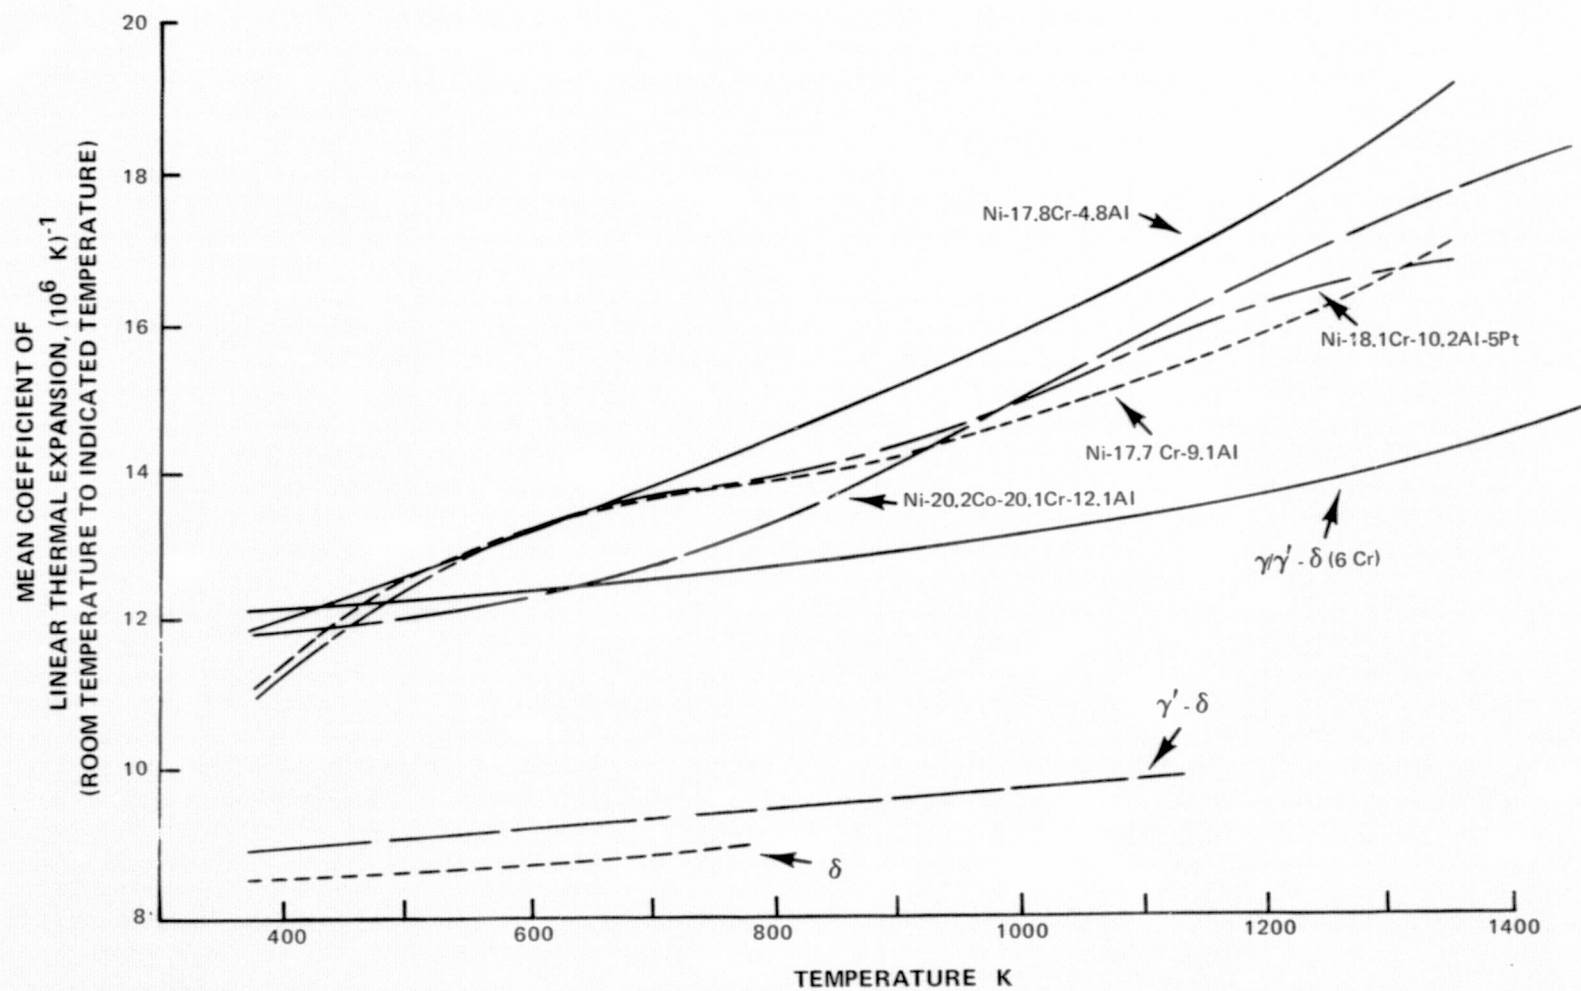
Figure 14 Thermal Expansion Data

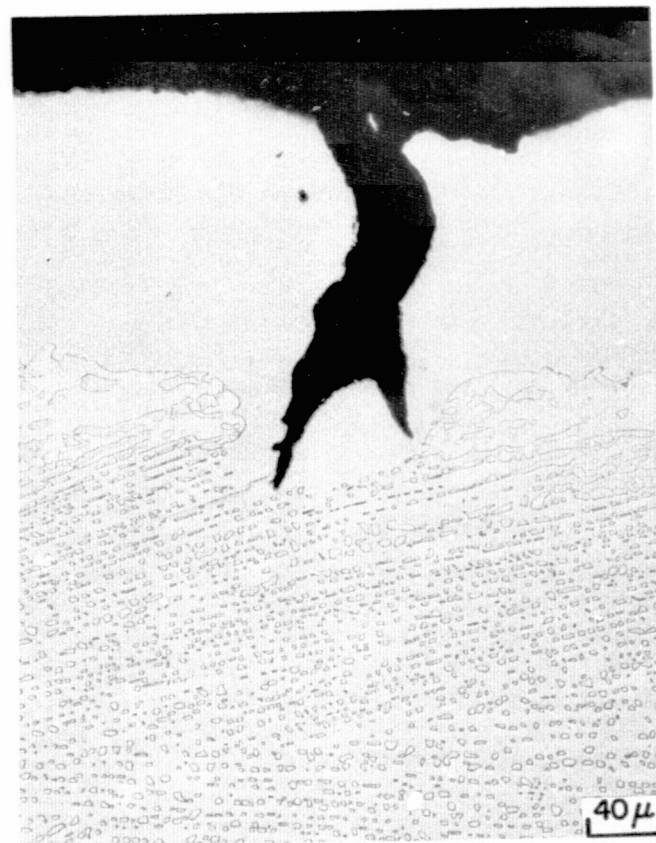
*Figure 15 Pretest and Post-Test Microstructures and Thermal Fatigue Crack Morphology of NiCrAlY + Diffusion Aluminide Coated  $\gamma/\gamma'$ - $\delta$  Specimen After 505 Hours of Evaluation in 1366 K (2000°F) Burner Rig Cyclic Oxidation Test (Cycle: 27 Minutes Hot – 3 Minutes Forced Air Cool).*

Post-test metallographic examination of the NiCrAlY + diffusion aluminide coated  $\gamma/\gamma' - \delta$  specimen (Figure 15) indicated that the hot zone coating was depleted of the aluminum rich  $\beta$  and  $\gamma'$  phases and was  $\gamma$  phase at the completion of testing. A band of  $\gamma'$  was present in the diffusion affected substrate zone was approximately 60 to 70  $\mu$ . The amount of aluminum depletion from the coating is associated with repeated spallation of the protective alumina scale; scale spallation was first observed after 56 hours of testing.

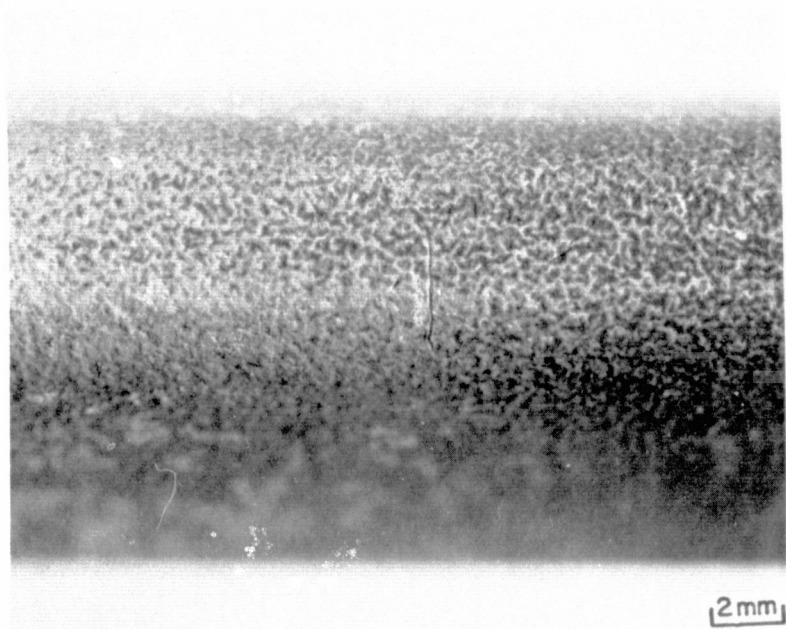
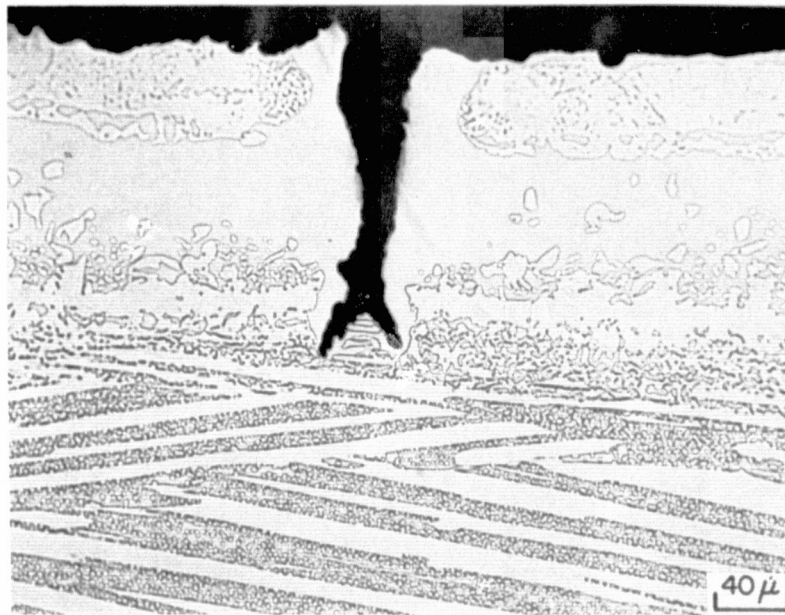
Figure 16 Surface and Cross-Section Morphology of Crack in NiCrAlY + Diffusion Aluminide Coated  $\gamma/\gamma'$ - $\delta$  Specimen After 505 Hours of Evaluation in 1366 K (2000°F) Burner Rig Cyclic Oxidation Test. This crack was detected in the coating prior to testing. (K-15102)

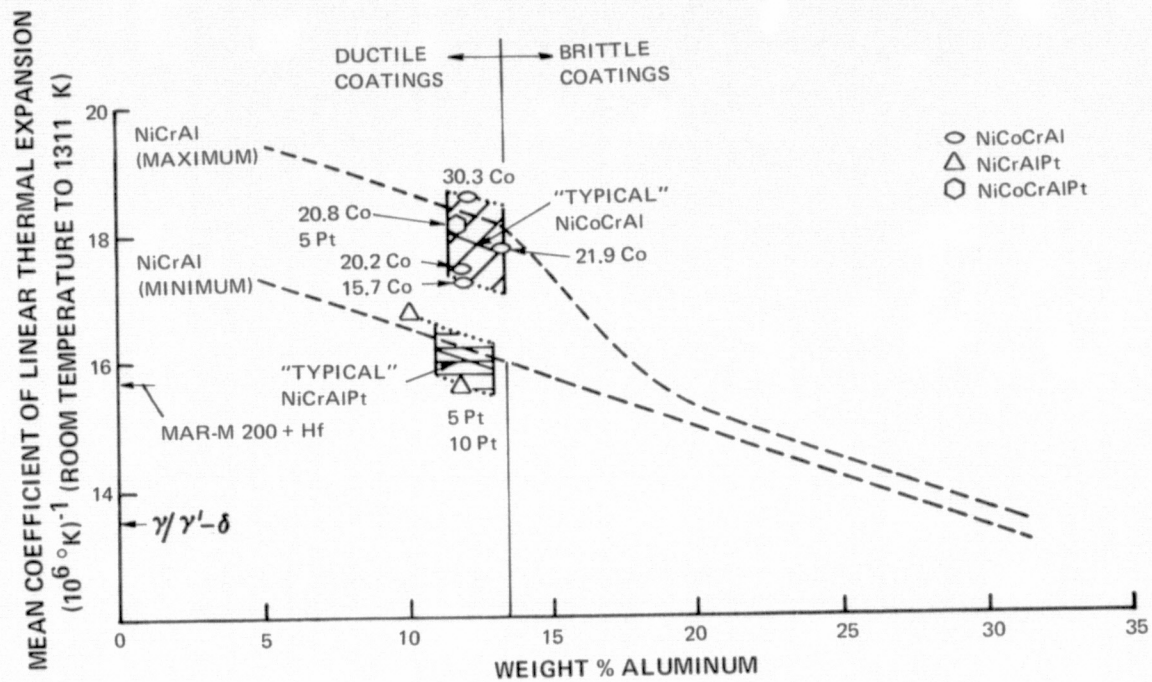
Figure 17 Effect of Cobalt and Platinum Additions on 1311 K (1900°F) NiCrAl Thermal Expansion

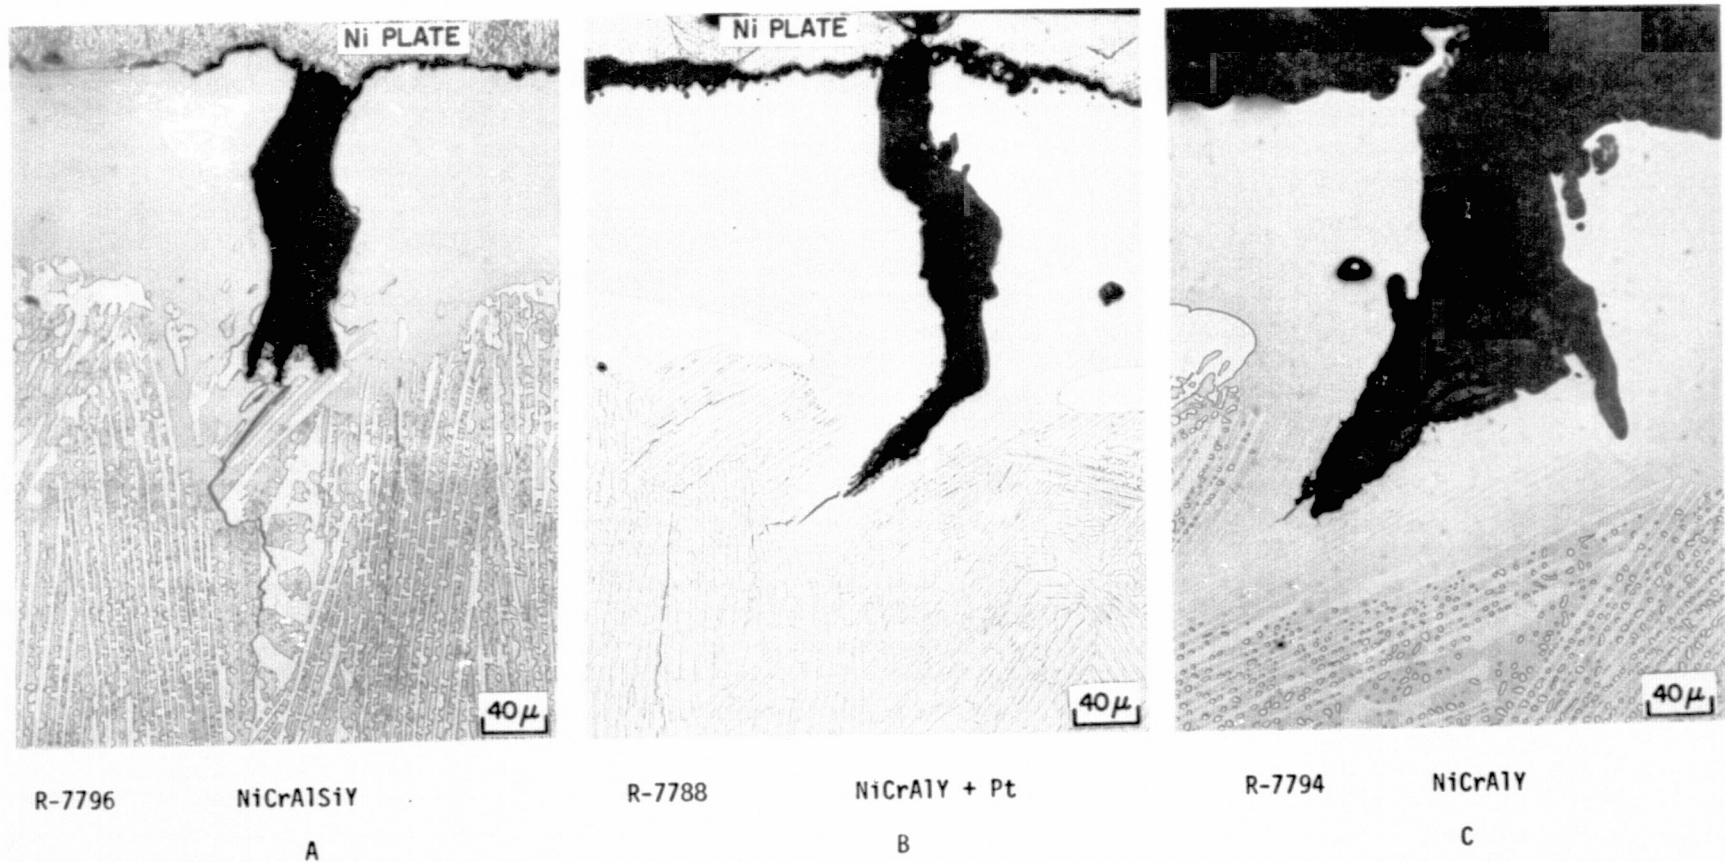
Figure 22 Relatively Severe Thermal Fatigue Cracks in (A) NiCrAlSiY, (B) Unrepaired NiCrAlY + Pt And (C) NiCrAlY Coated  $\gamma/\gamma'$ - $\delta$  Specimens Which Developed During 1366 K (2000°F) Burner Rig Test. Unoxidized crack extension into the  $\gamma/\gamma'$ - $\delta$  substrate is thought to have occurred during post-test metallographic preparation. (K-20919)

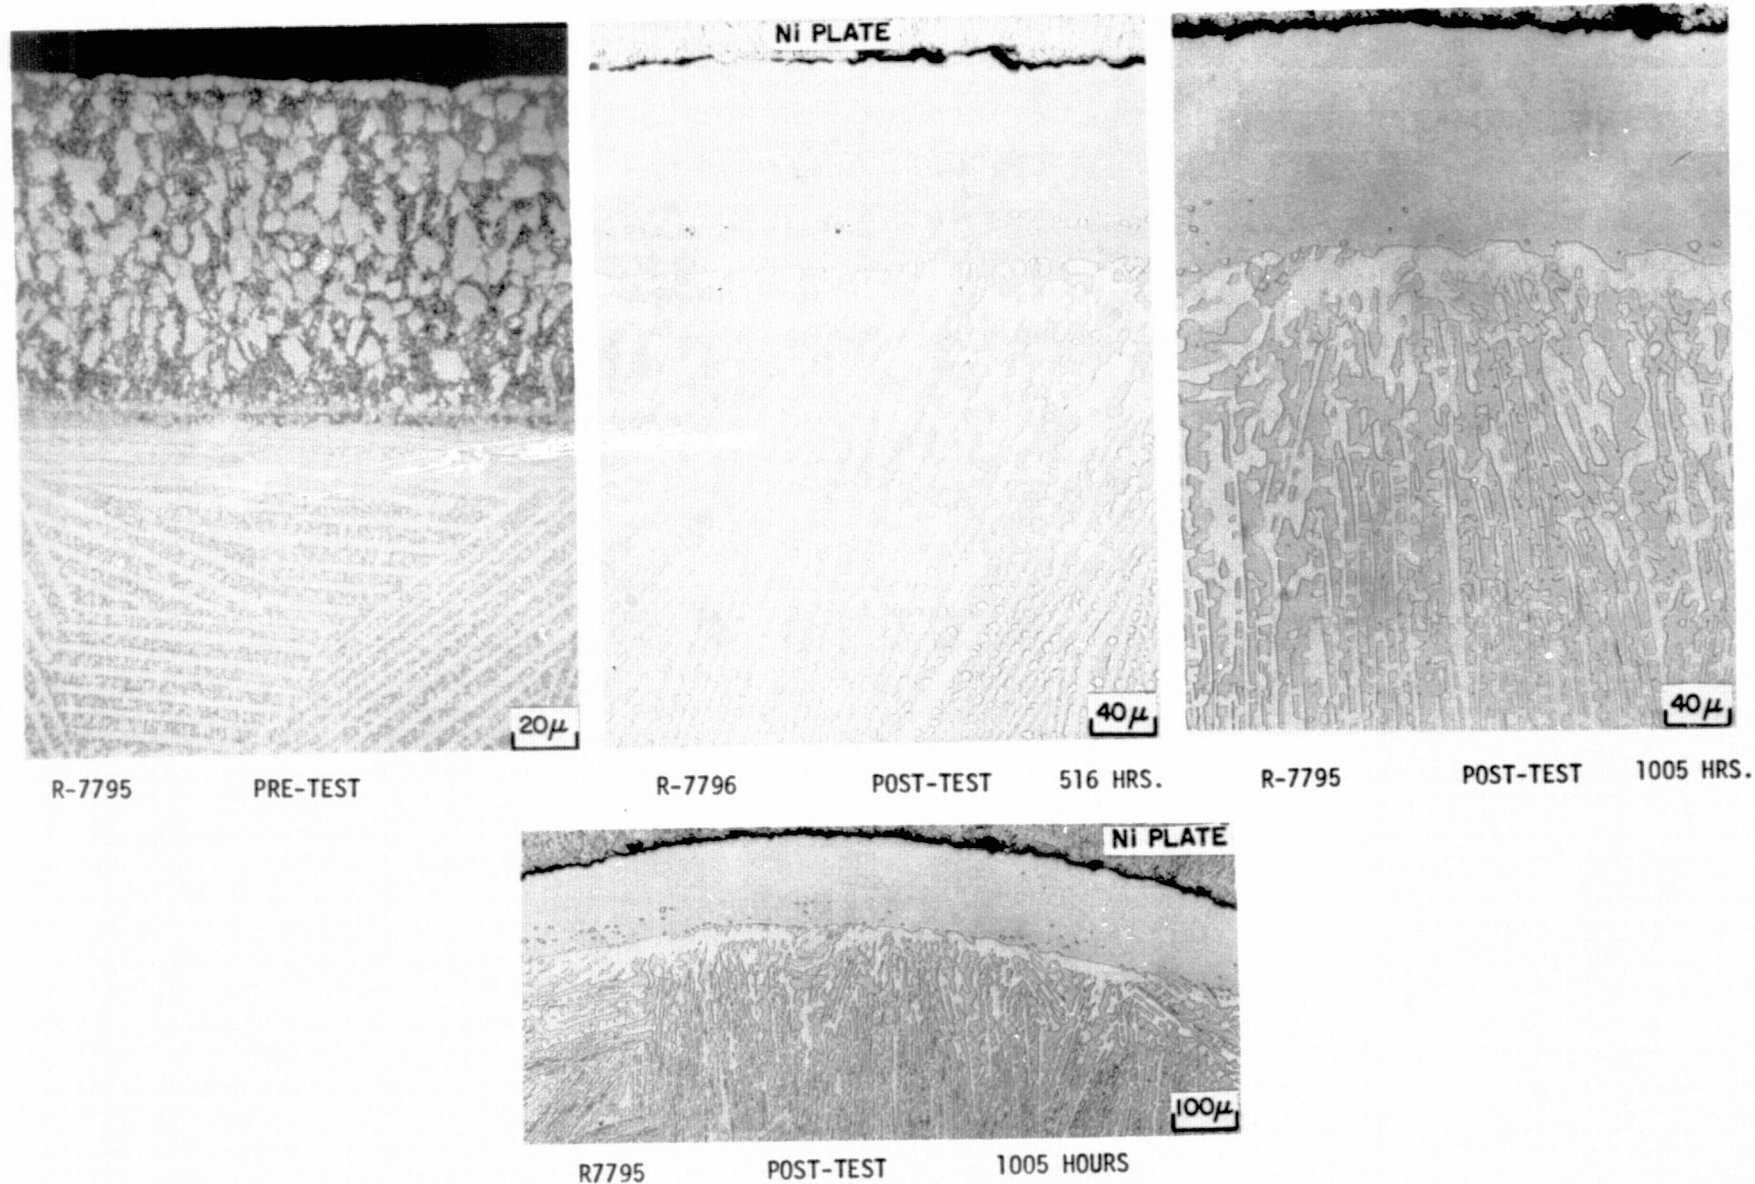
Figure 23 Pretest and Post-Test Microstructures of NiCrAlSiY Coated  $\gamma/\gamma'$ - $\delta$  Specimens After 516 And 1005 Hours of Evaluation in 1366 K (2000°F) Burner Rig Cyclic Oxidation Test (Cycle: 55 Minutes Hot – 5 Minutes Forced Air Cool). (K-20920)

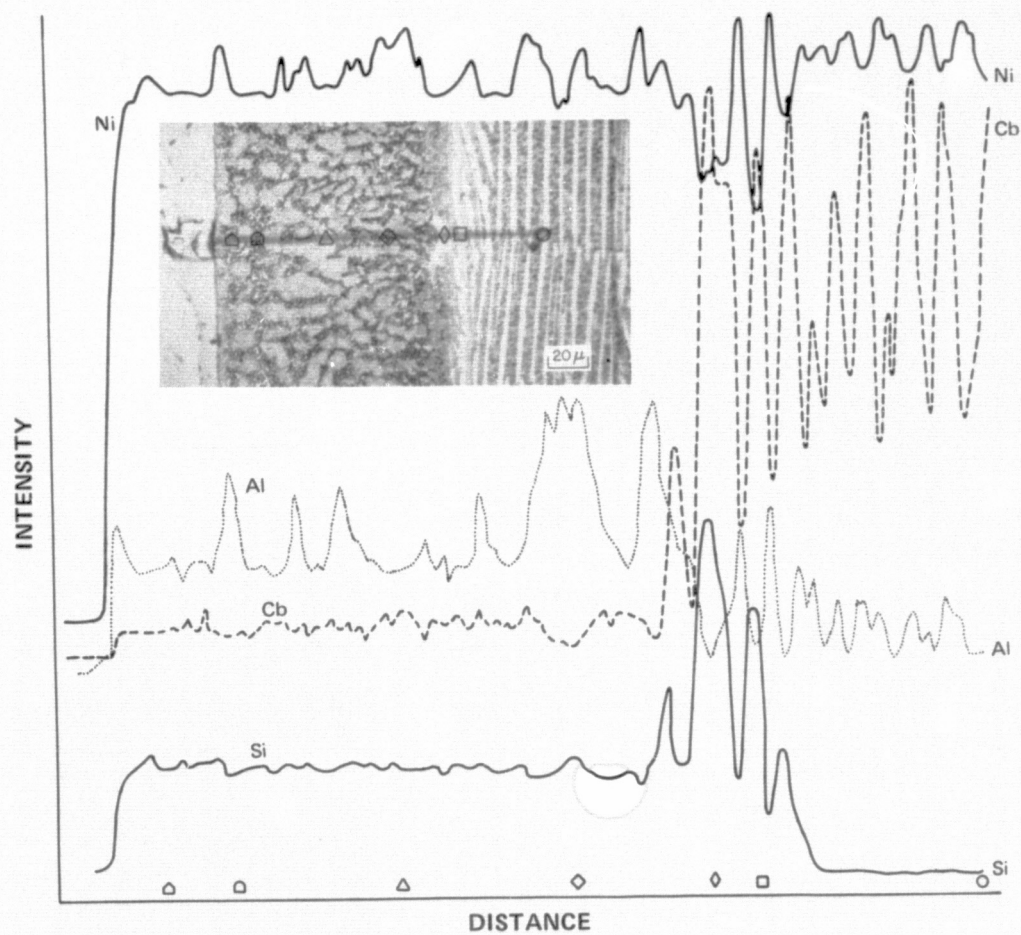
Figure 24 Relative Nickel, Aluminum, Silicon and Columbium X-Radiation Intensities of NiCrAlSiY Coated  $\gamma/\gamma'$ - $\delta$  (Ni-19.7Cb-6Cr-2.5Al) Specimen in Pretest Condition.

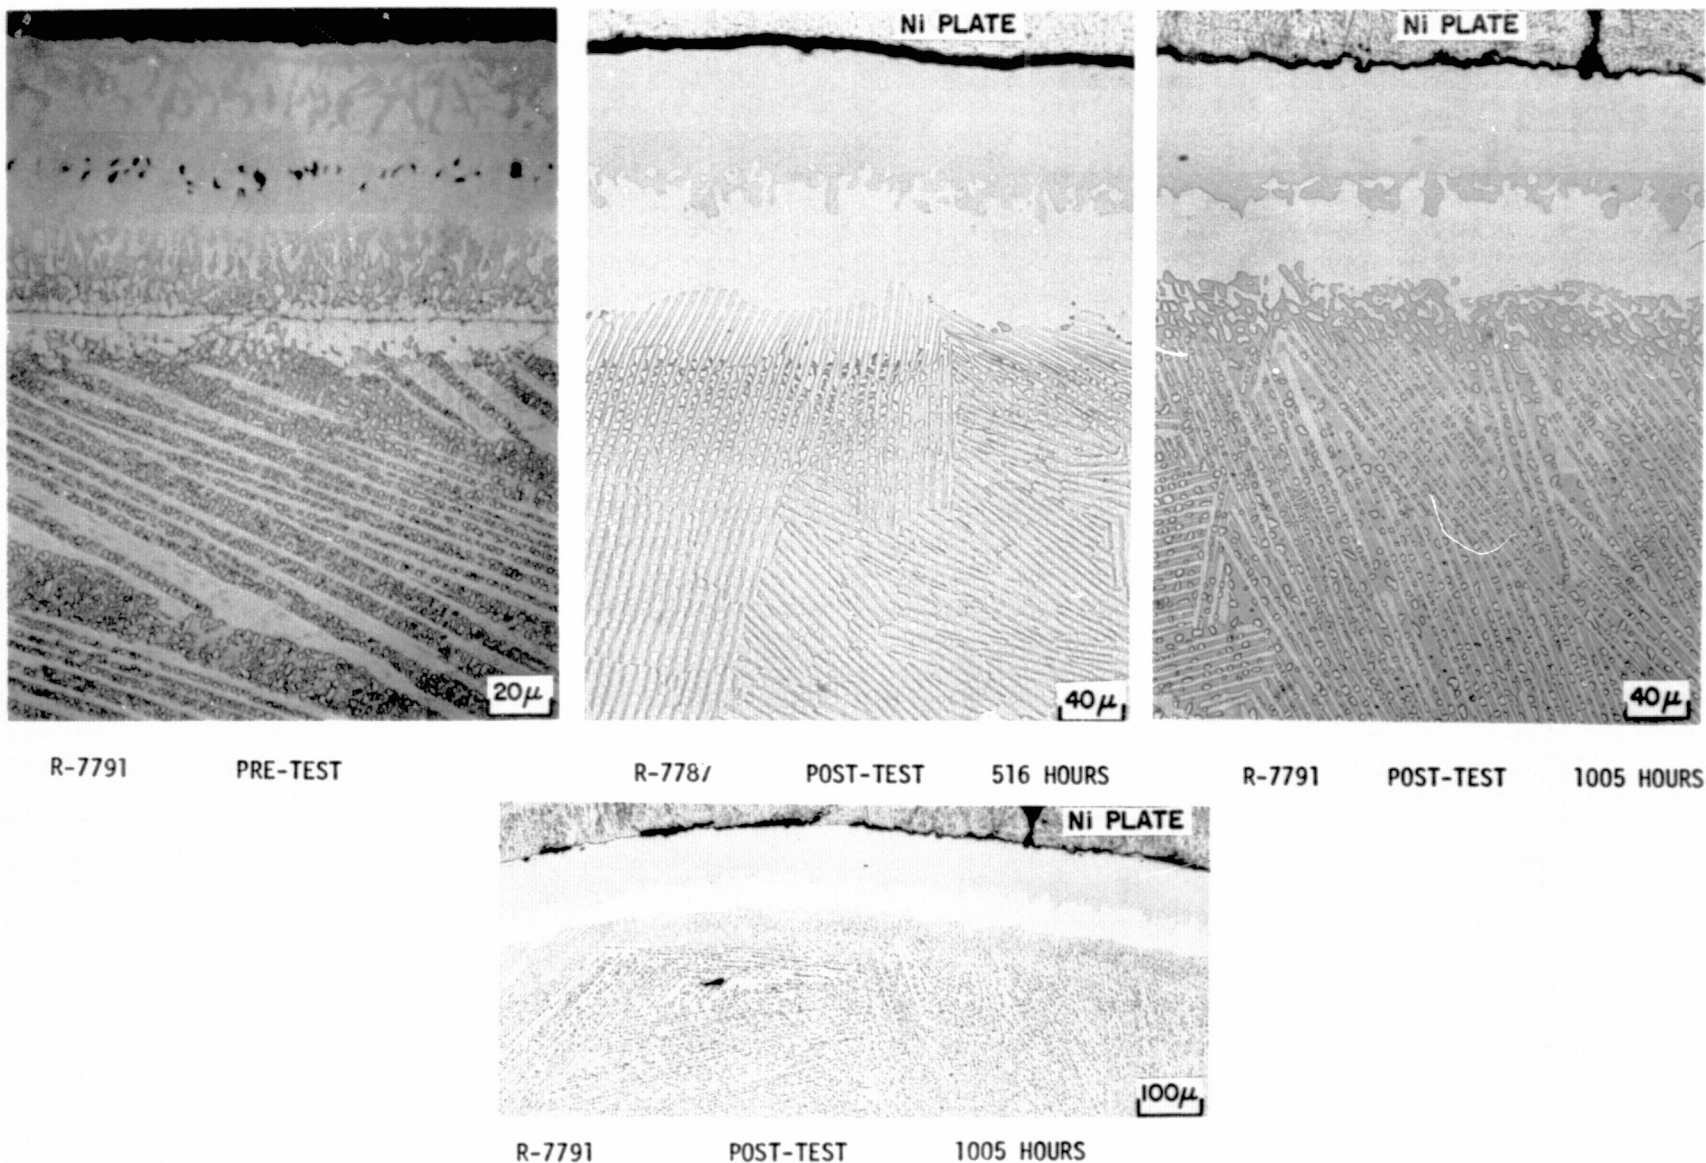
Figure 26 Pretest and Post-Test Microstructures of Repaired NiCrAlY + Pt Coated  $\gamma/\gamma' - \delta$  Specimens After 516 and 1005 Hours of Evaluation in 1366 K (2000°F) Burner Rig Cyclic Oxidation Test (Cycle: 55 Minutes Hot – 5 Minutes Forced Air Cool). (K-20922)

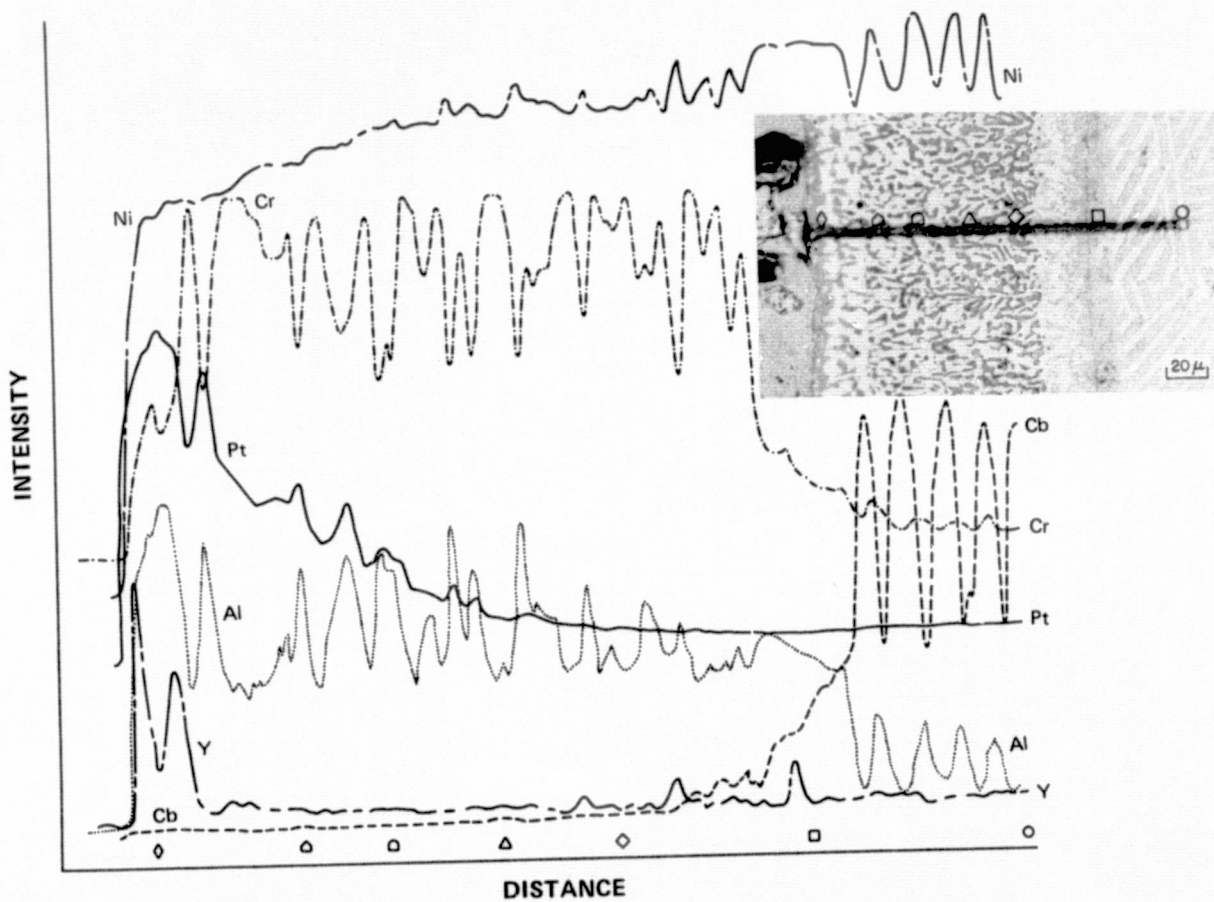
Figure 29 Relative Nickel, Chromium, Aluminum, Yttrium, Platinum and Columbium X-Radiation Intensities of Unrepaired NiCrAlY + Pt Coated  $\gamma/\gamma'$ - $\delta$  (1Cr) Specimen in Pretest Condition.

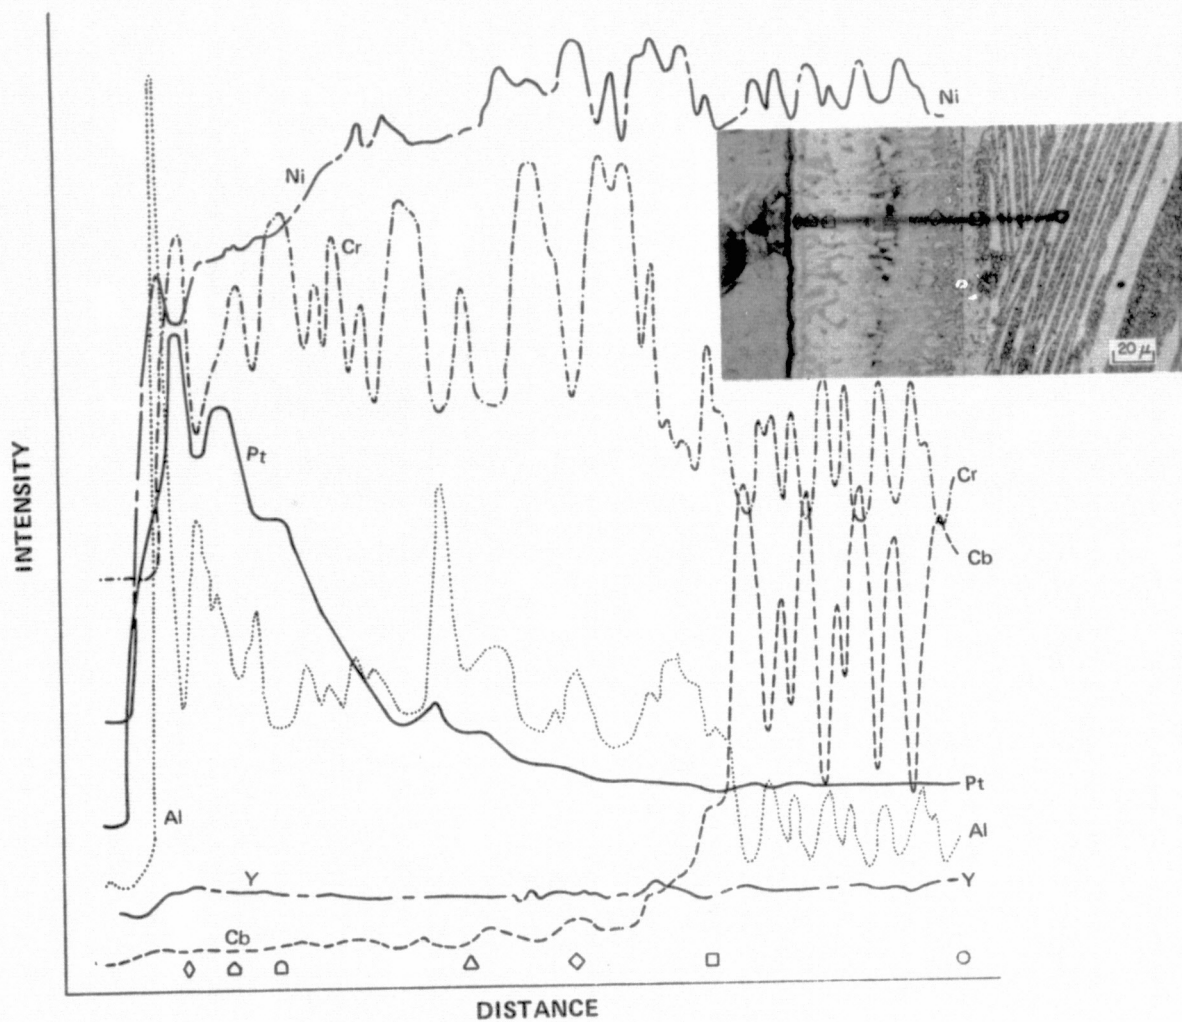
Figure 30 Relative Nickel, Chromium, Aluminum, Yttrium, Platinum and Columbium X-Radiation Intensities of Repaired NiCrAlY + Pt Coated  $\gamma/\gamma'$ - $\delta$  (6Cr) Specimen in Pretest Condition.
